Flow Visualization Study of a 1/48-Scale AFTI/F111 Model to Investigate Horizontal Tail Flow Disturbances

Lisa J. Bjarke
Ames Research Center, Dryden Flight Research Facility, Edwards, California

(NASA-TM-101698) FLOW VISUALIZATION STUDY
OF A 1/48-SCALE AFTI/F111 MODEL TO
INVESTIGATE HORIZONTAL TAIL FLOW
DISTURBANCES (NASA) 35 p

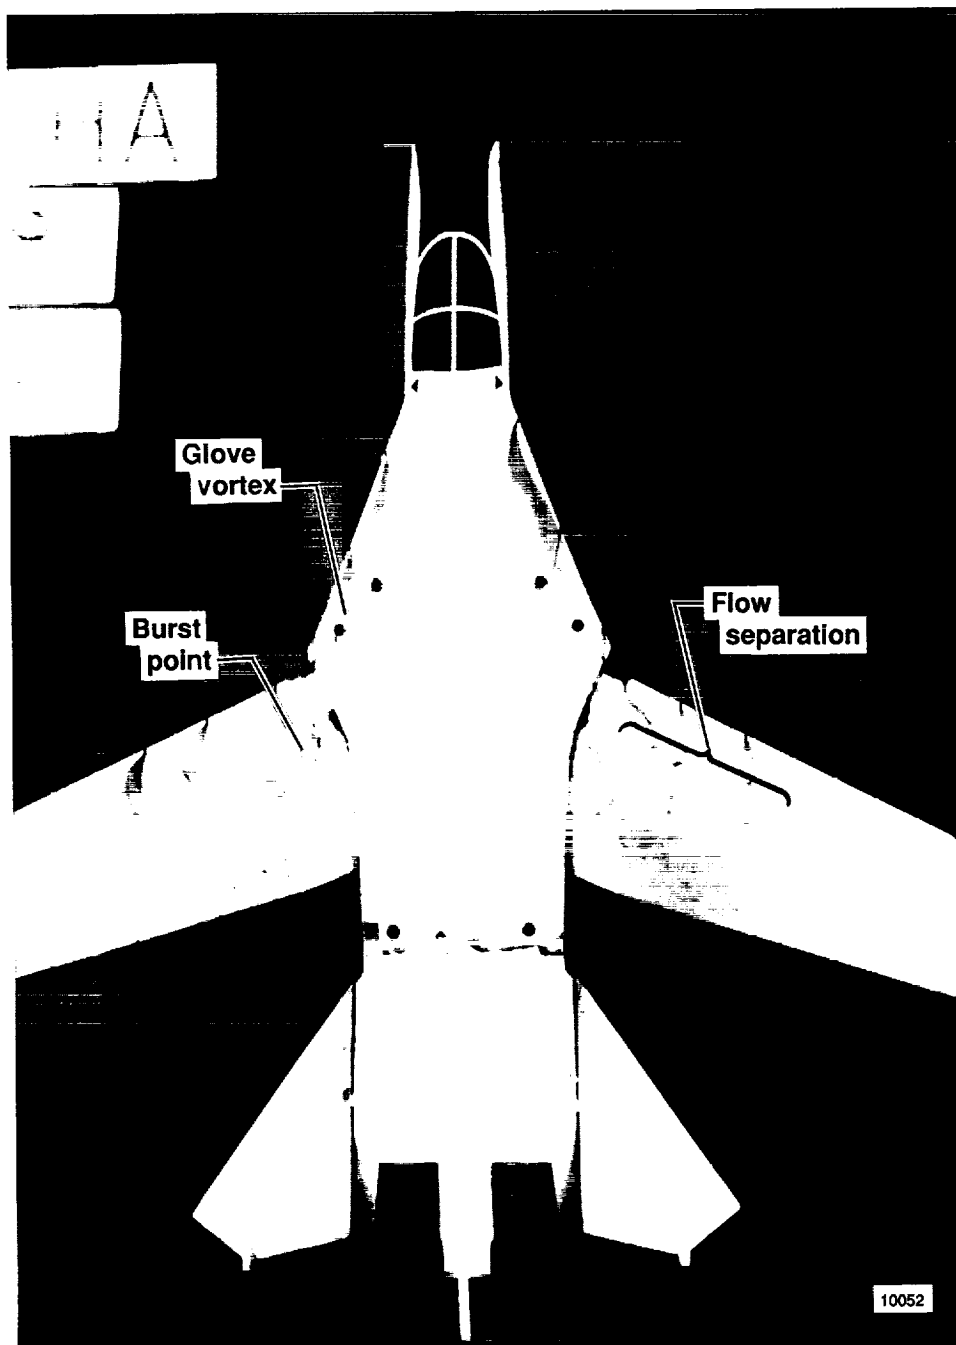
(a) Plan view.

At $\alpha = 8^\circ$, the plan view (fig. 4(a)) shows that wing flow separation occurs just behind the leading-edge devices. The glove vortex burst point is near the wing root at approximately mid-chord. (It should be noted that the path of this vortex and its effect on the flow over the wing agreed with wind-tunnel tuft flow visualization results from a Boeing study summarized by Nelson (1982)). The side view (fig. 4(b)) shows that the wing separation and glove vortex flow goes above the horizontal tail while the lower surface of the horizontal tail experiences a different flow field. This type of flow field on the horizontal tail could be the cause of the slight horizontal tail buffet experienced in flight at similar test conditions as discussed by Friend (1989). Also visible in the side view is a weak vortex that begins at the engine inlet lip-fuselage juncture, travels aft along the fuselage and causes a flow disturbance both above and below the horizontal tail root.

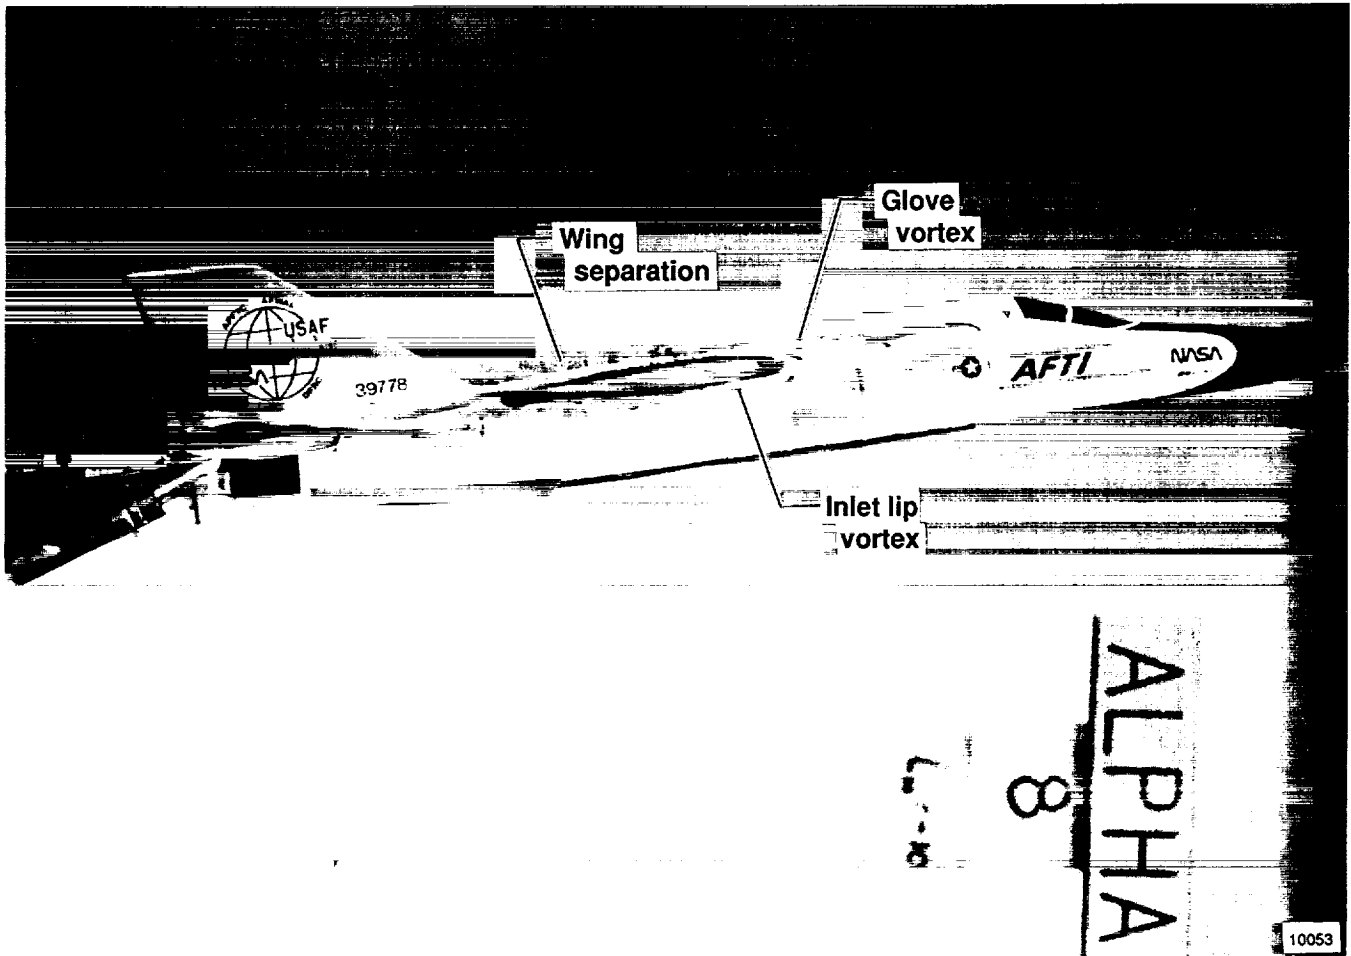
(b) Side view.

Figure 5 presents the flow visualization results at $\alpha = 10^\circ$ for this configuration. With the increase in angle of attack, flow separation on the wing moved slightly forward (fig. 5(a)). In addition, there is now both a primary and secondary glove vortex, both of which burst slightly further forward on the wing than at $\alpha = 8^\circ$ (fig. 4(a)). In the side view (fig. 5(b)), the separated and vortex flow field from the wing can again be seen traveling above the horizontal tail. However, at this angle of attack, more of the inlet lip vortex goes beneath the horizontal tail than at $\alpha = 8^\circ$ (fig. 4(b)).

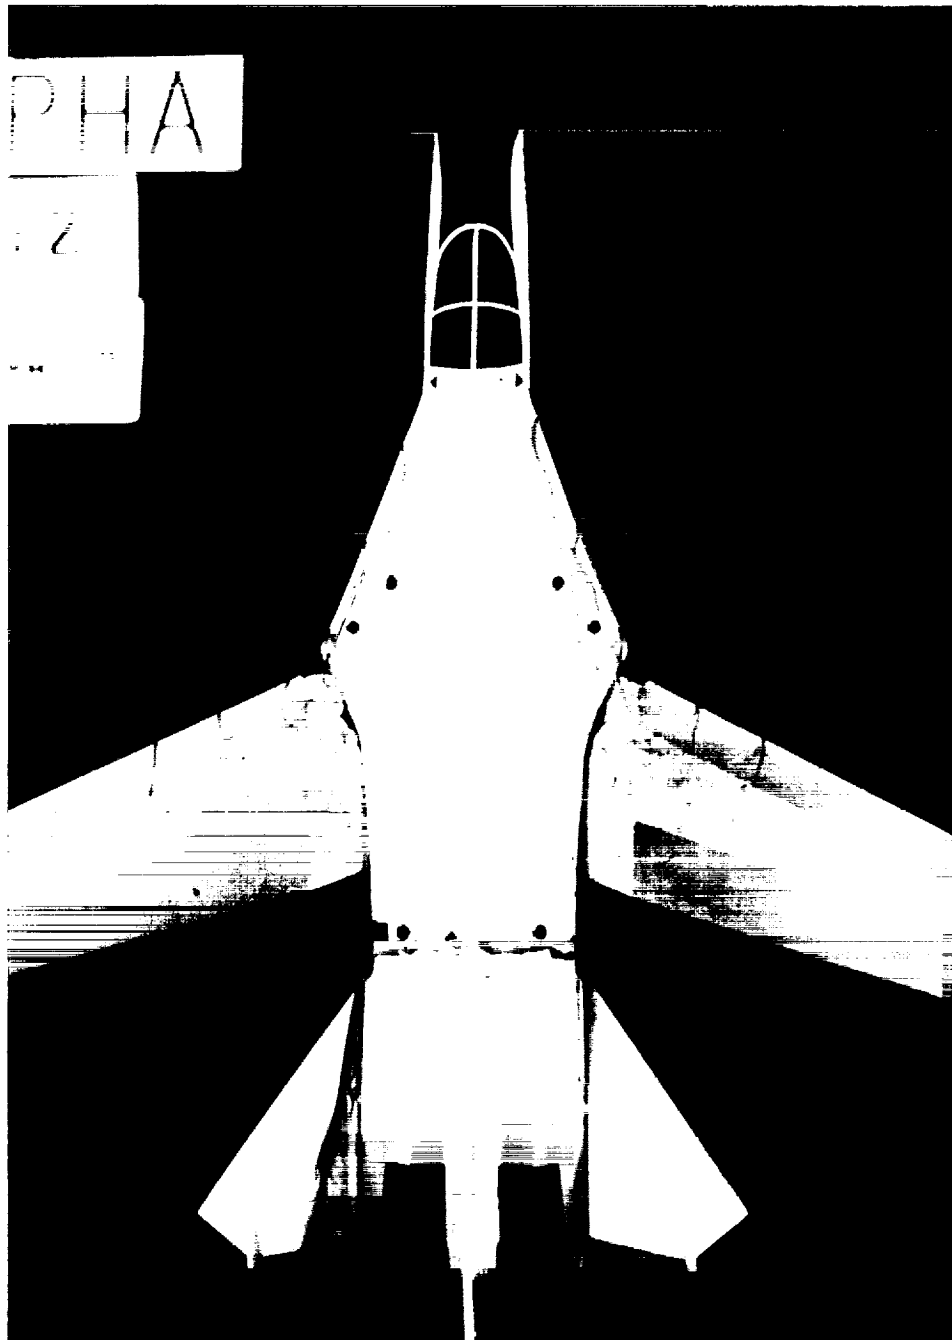
(a) Plan view.

At $\alpha = 12^\circ$, (fig. 6(a)), more of the wing is separated, especially inboard. This is because the burst point of the secondary glove vortex has moved forward to the wing-glove juncture. The primary vortex is stronger but its burst point is at approximately the same place as it was at $\alpha = 10^\circ$ (fig. 5(a)). Most of the inlet lip vortex curves down away from the wing as it travels aft and goes under the horizontal tail (fig. 6(b)).

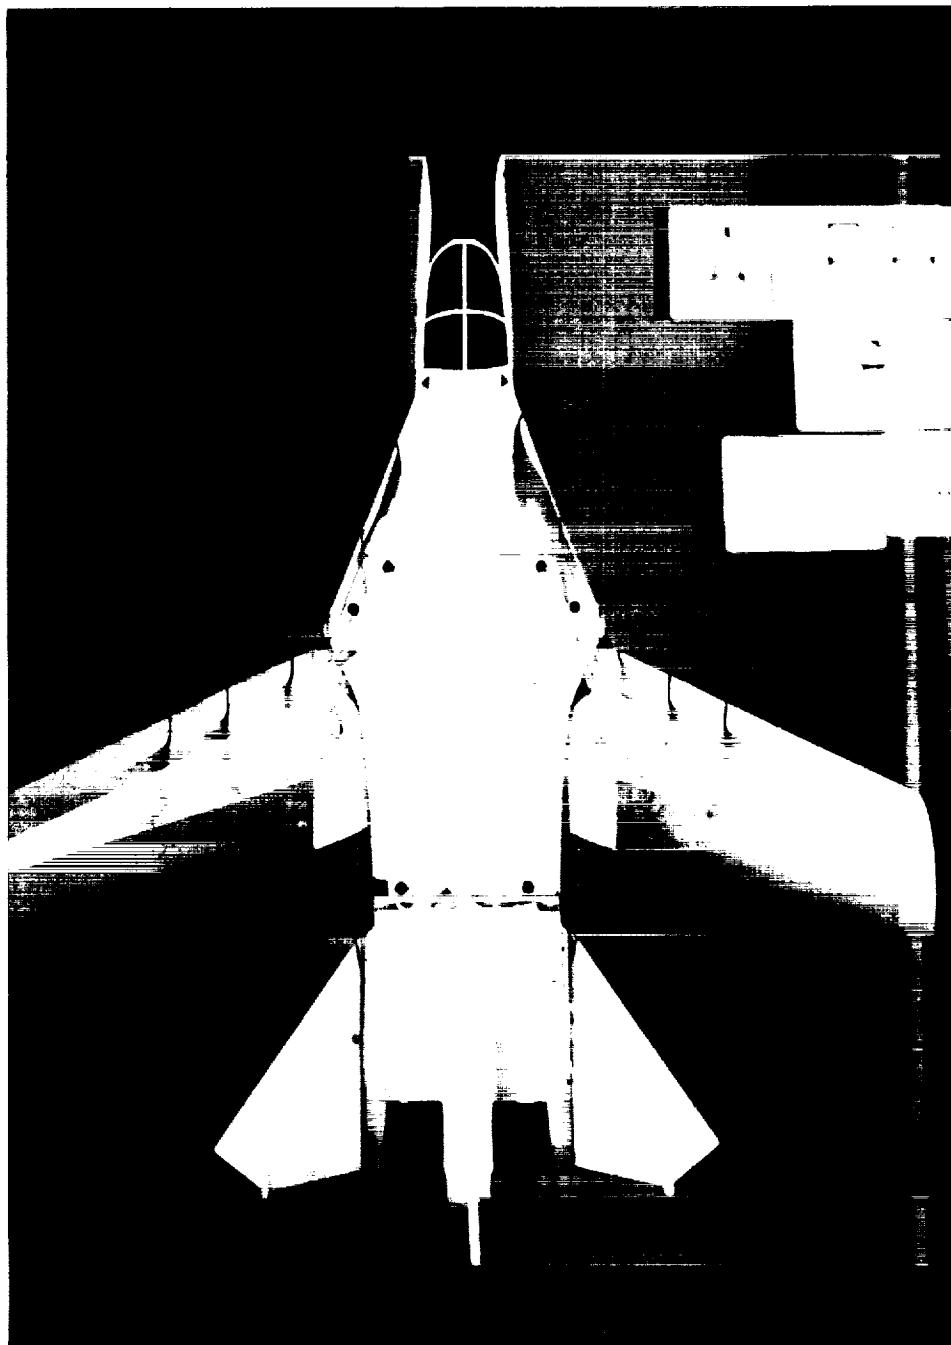
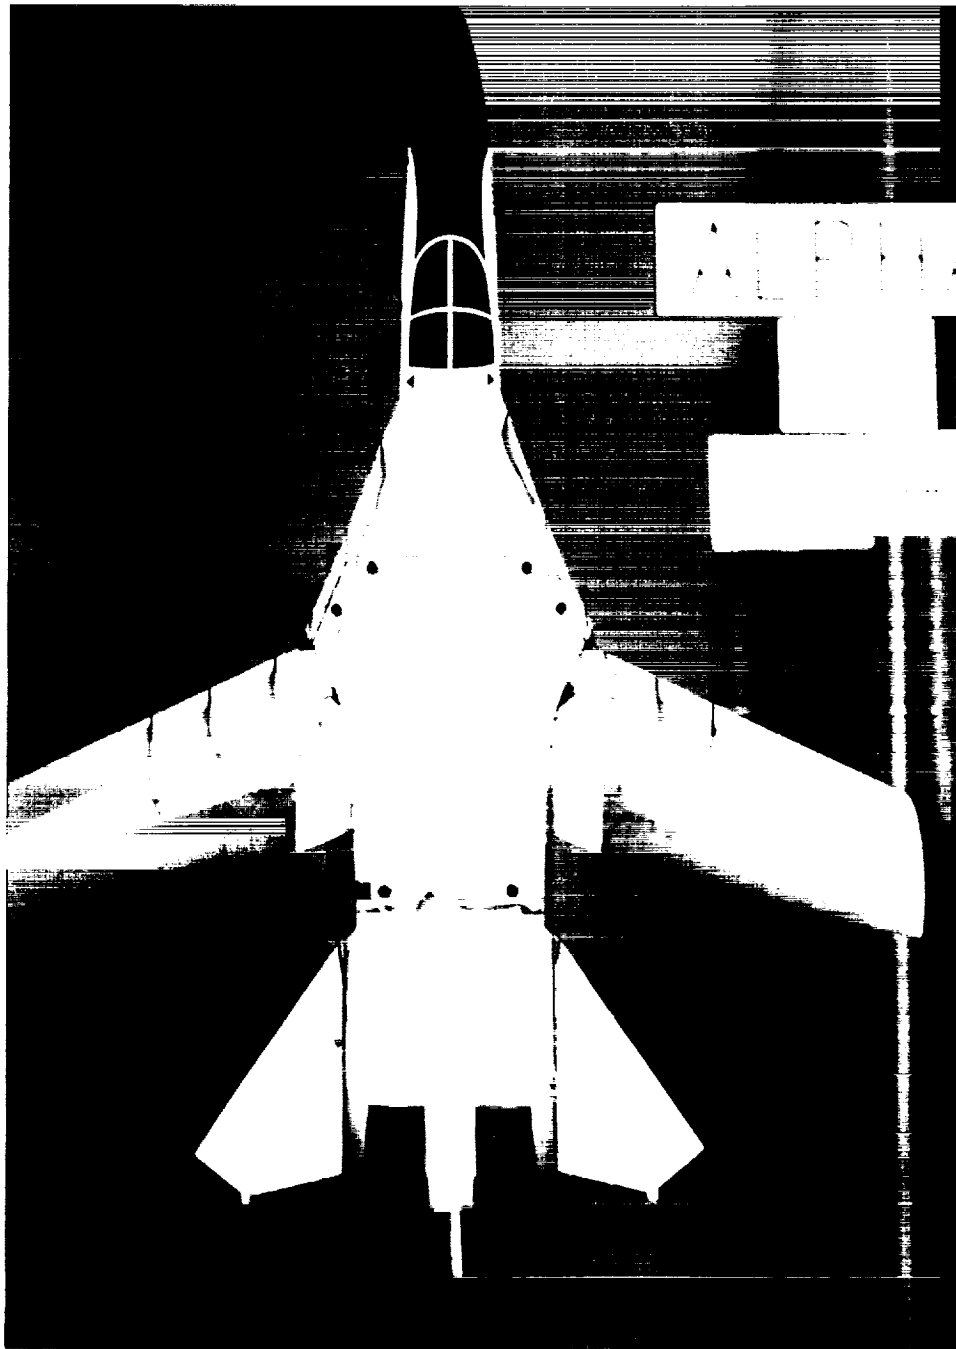
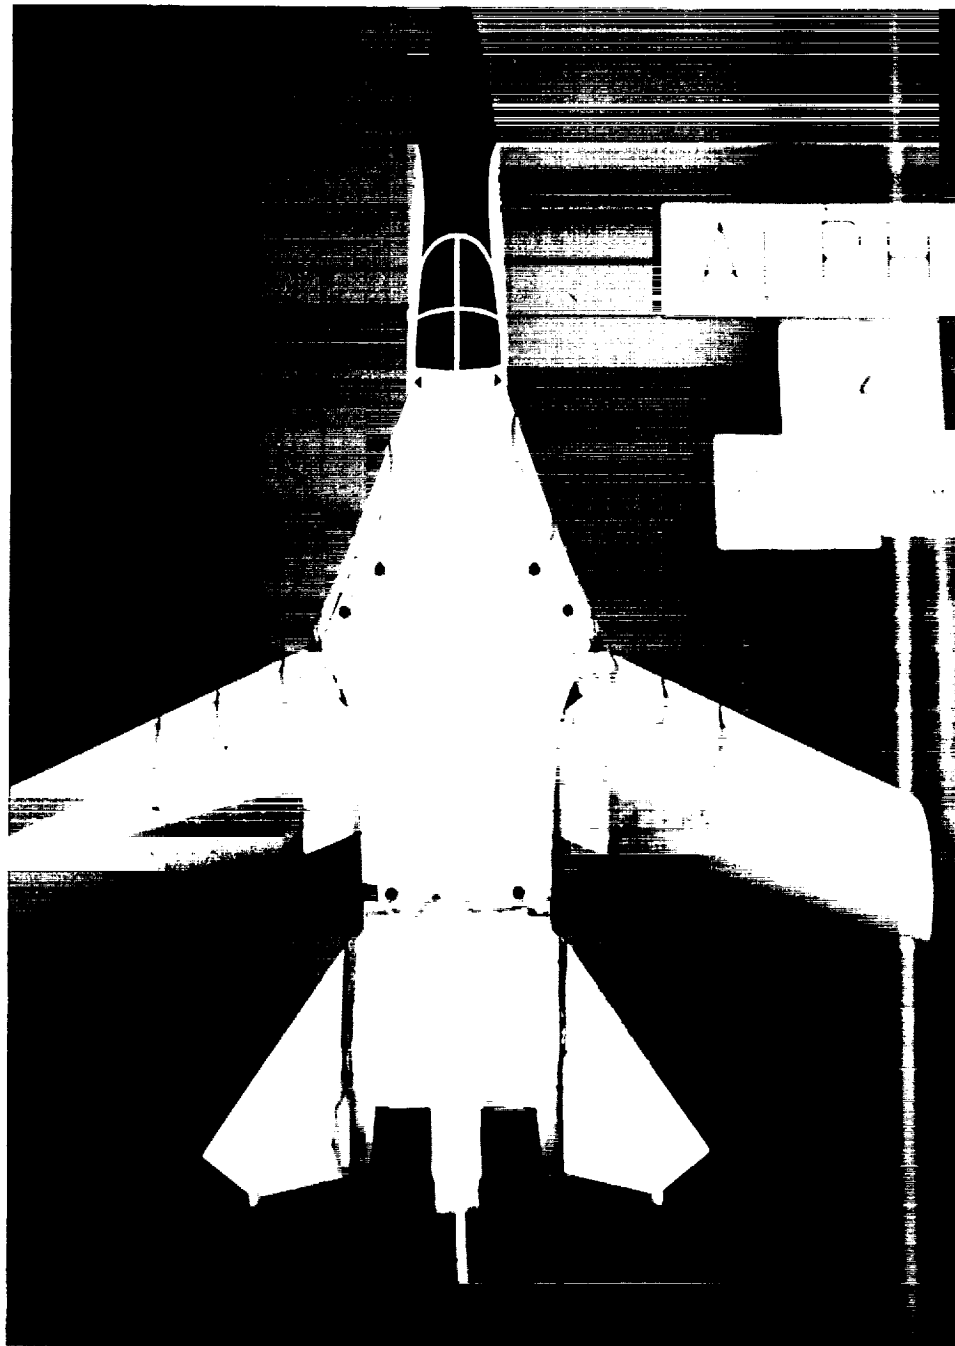
wing flow separation is further aft for this configuration (figs. 7(a), 8(a), and 9(a)), it still moves forward with increasing angle of attack as was discussed previously. The glove vortex follows similar behavior for this configuration as for the $\delta_{LE/TE} = 0/2$ configuration.

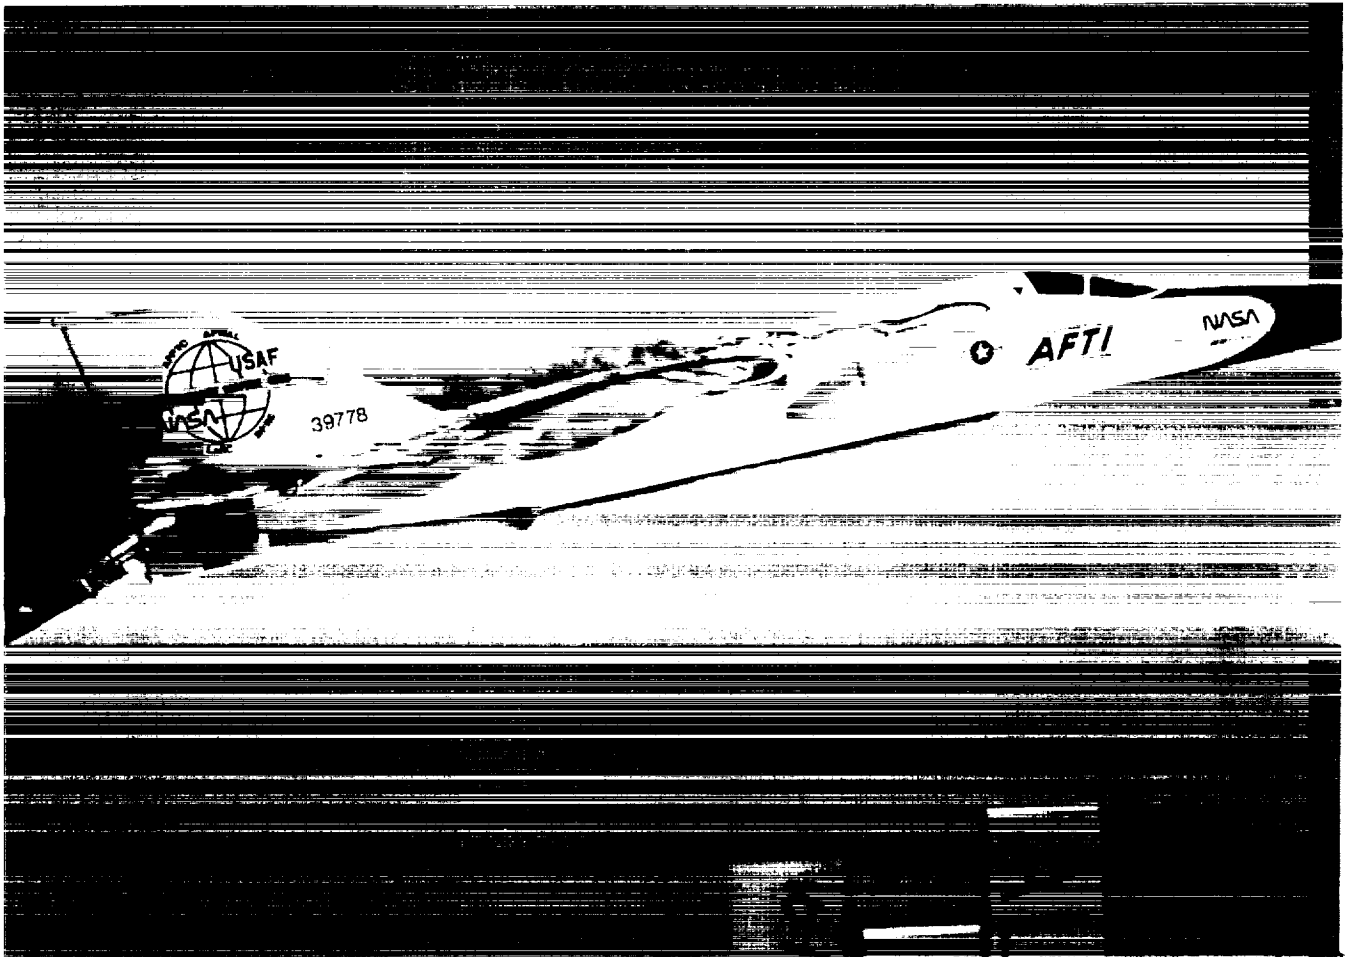
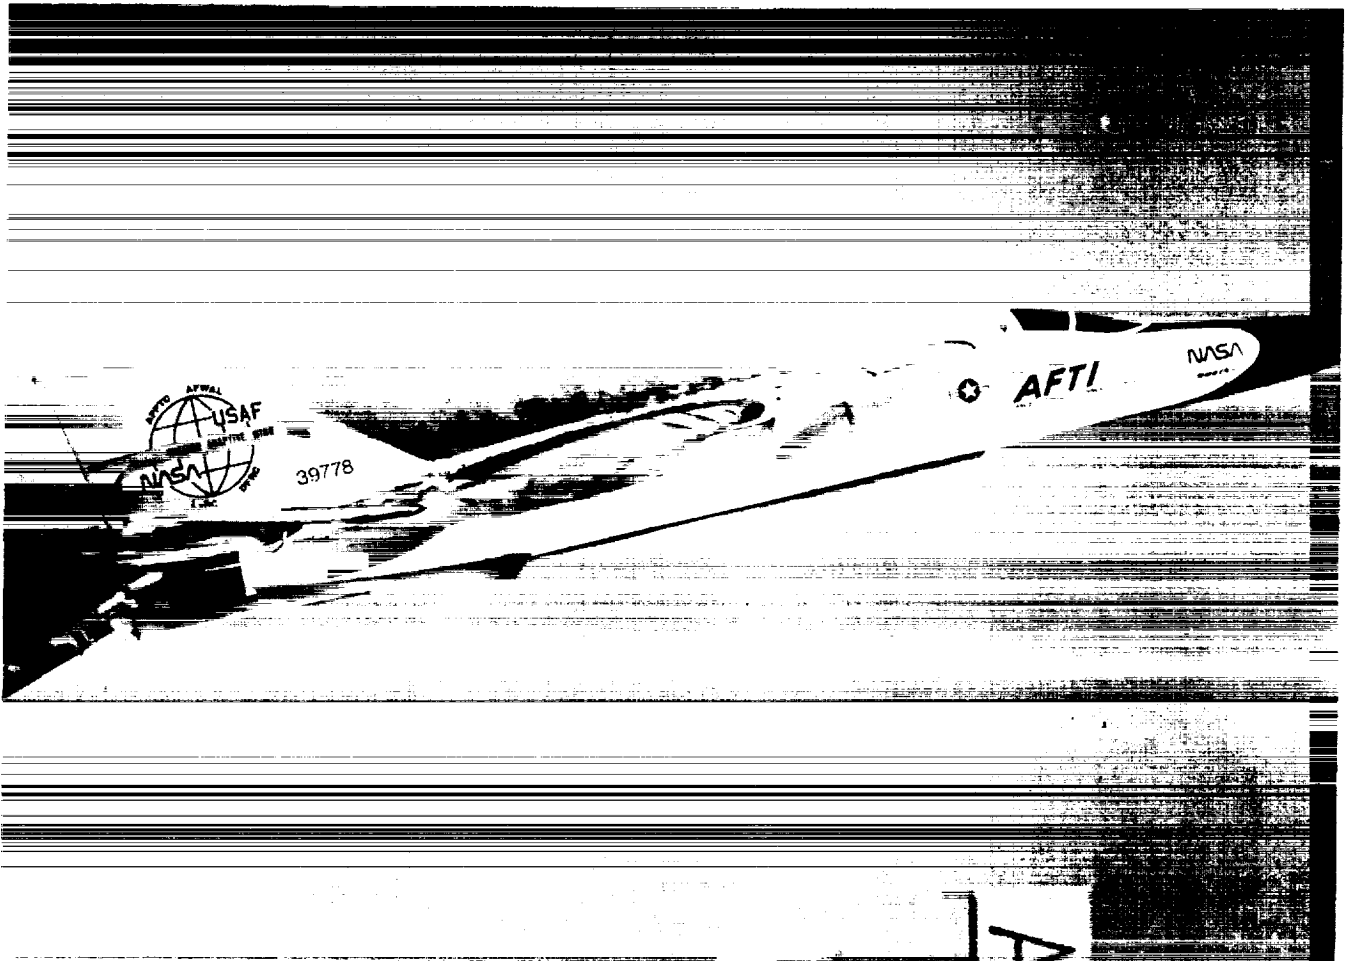
The side views (figs. 7(b), 8(b), and 9(b)) show that the separated and glove vortex flow from the wing still travel above the horizontal tail but turns downward near the trailing-edge device and interact more directly with the horizontal tail upper surface. The inlet lip vortex appears more circulatory (stronger) in nature and interacts directly with the horizontal tail at the root leading edge. This difference is most dramatic at $\alpha = 10^\circ$ and 12° (figs. 8(b) and 9(b)) where the inlet lip vortex engulfs the horizontal tail rather than traveling on one side or the other as was the case when $\delta_{LE/TE} = 0/2$ (figs. 5(b) and 6(b)). With the changes in the direction and placement of both the flow from the wing and the inlet lip, the horizontal tail is in a more disturbed flow field at $\delta_{LE/TE} = 10/10$ than at $\delta_{LE/TE} = 0/2$. These results are consistent with the findings of Friend (1989) which show increased horizontal tail buffet experienced in flight for similar test conditions.

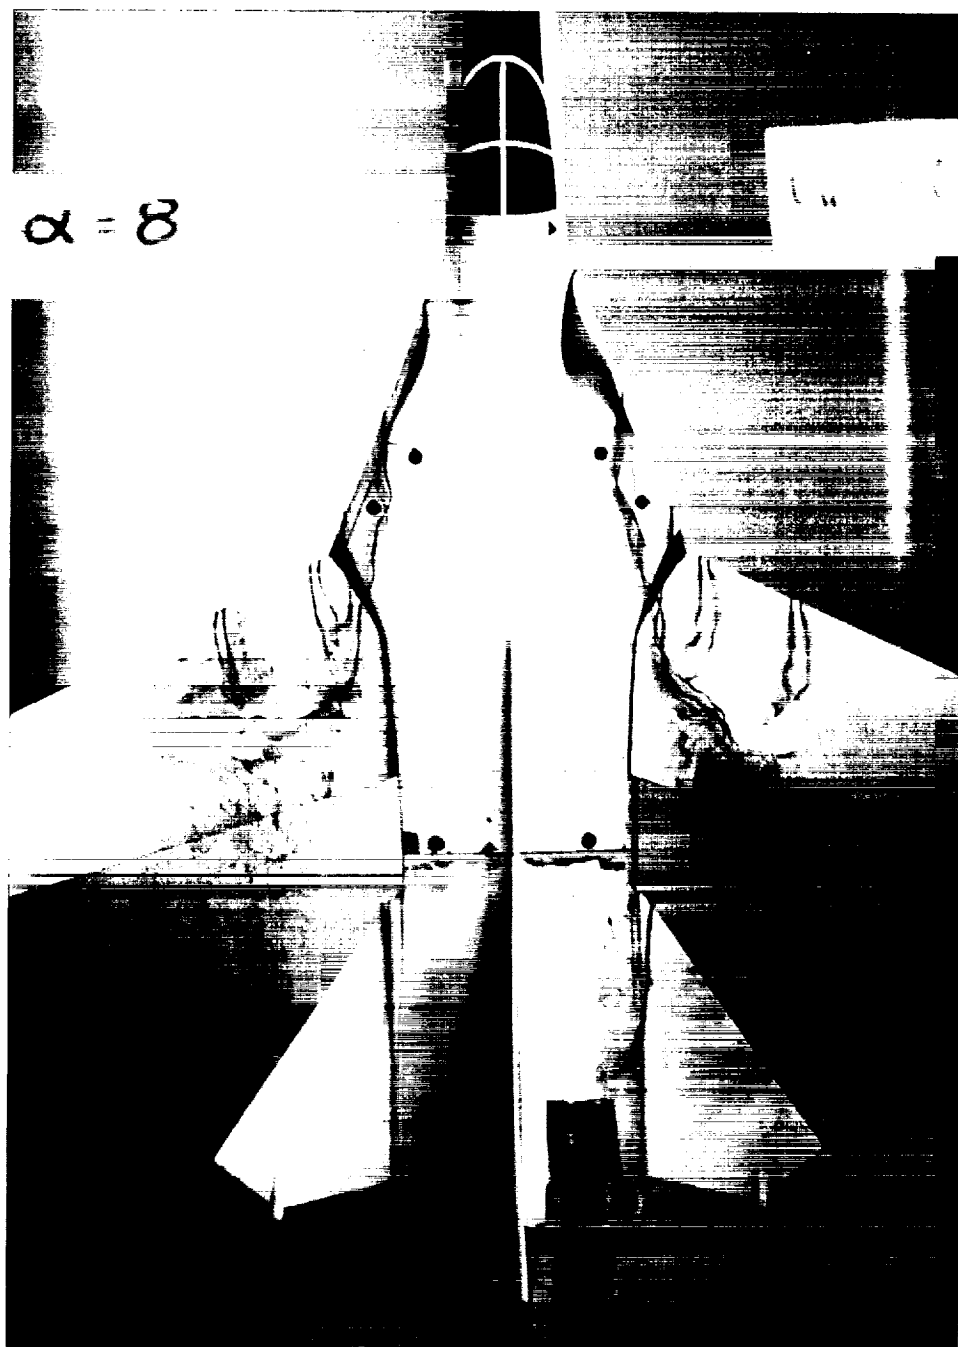
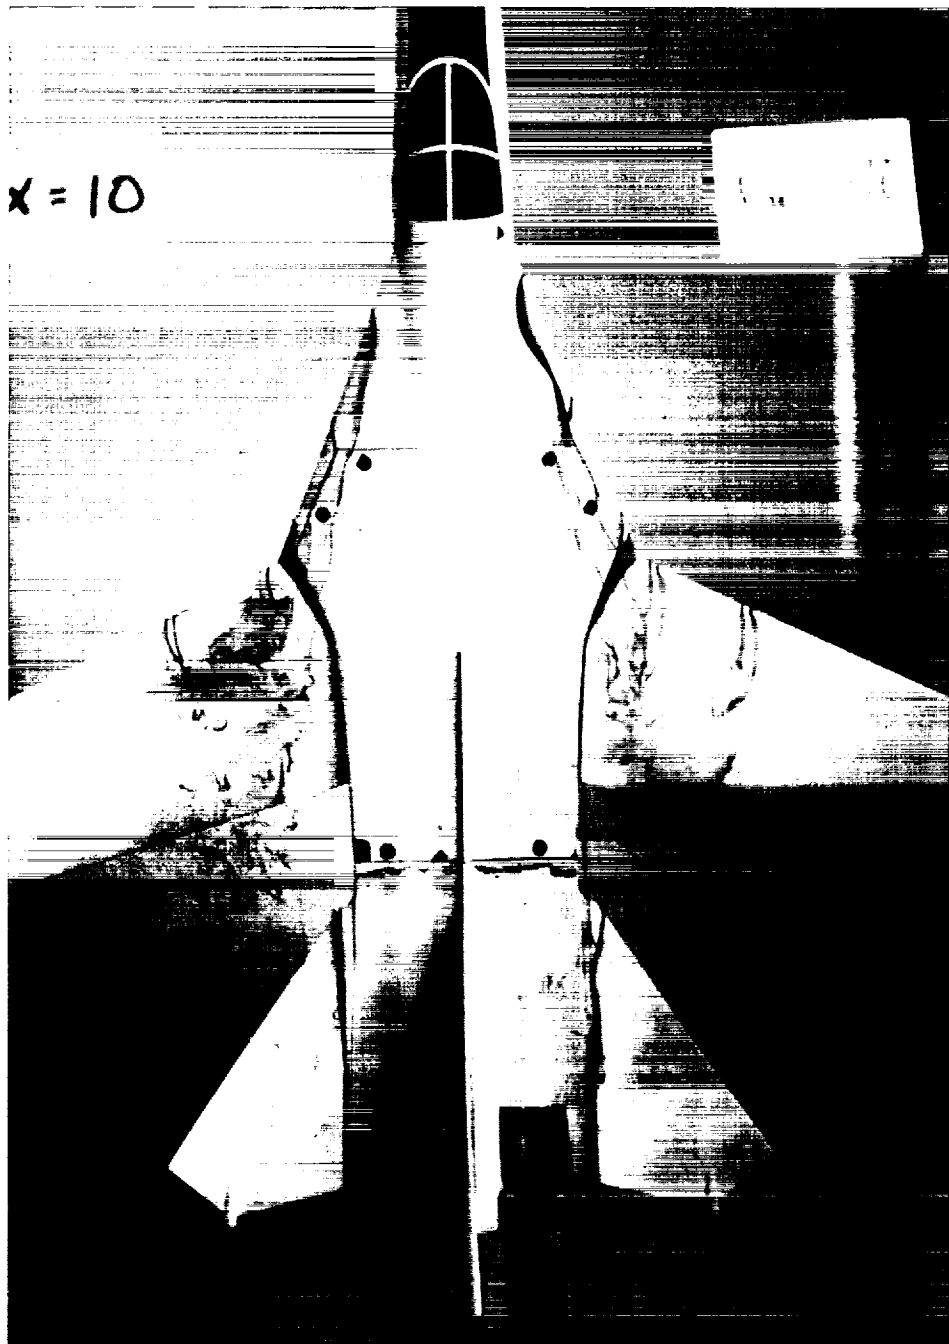
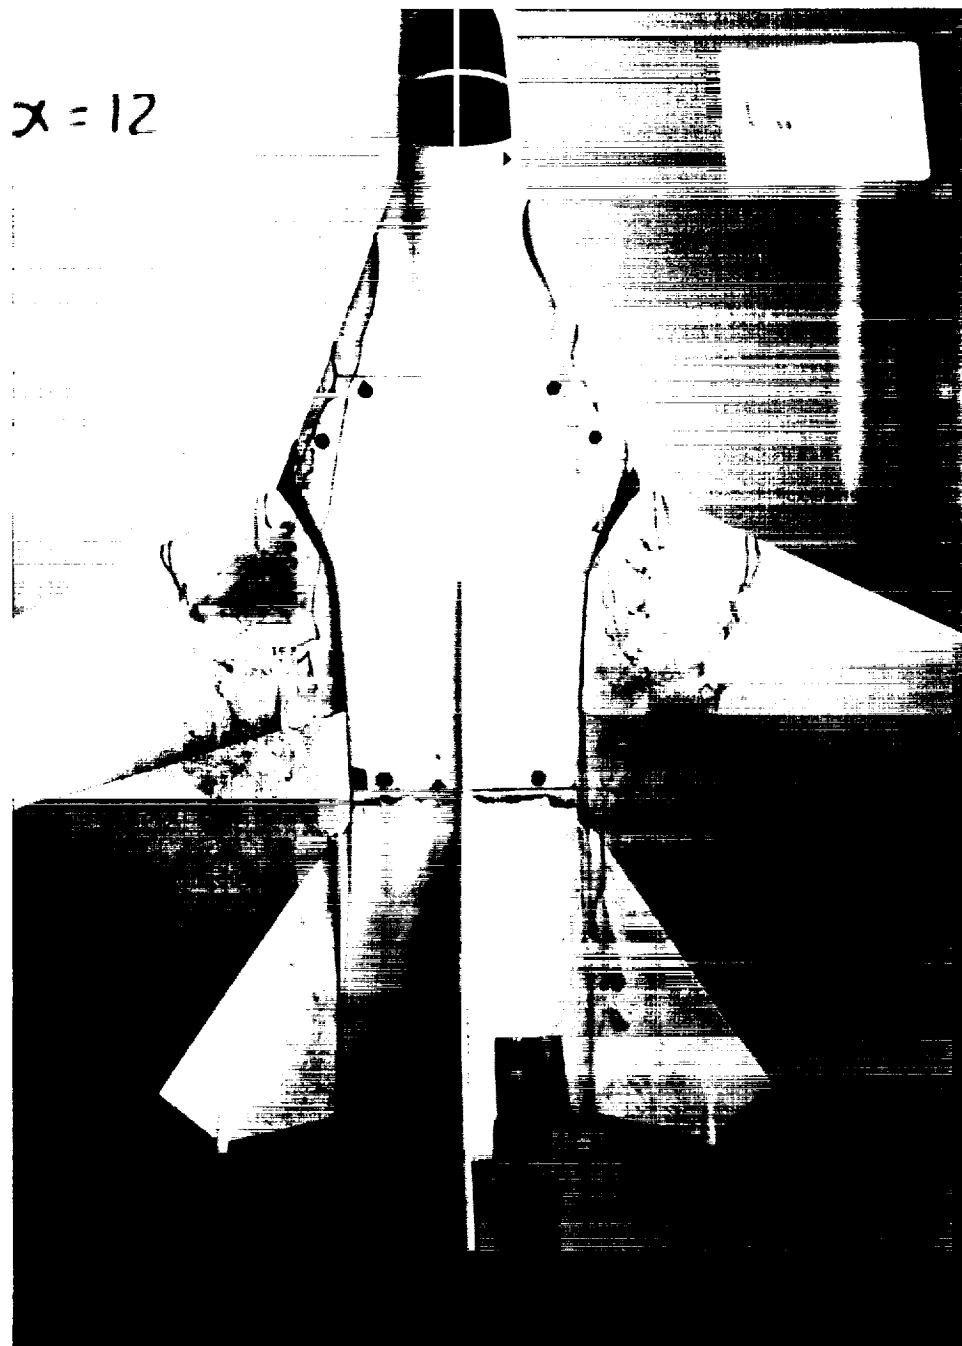
Figures 13 through 15 show the results for the $\delta_{LE/TE} = 0/10$ camber configuration. The behavior of the location of flow separation and glove vortex burst point (figs. 13(a), 14(a), and 15(a)) follow similar trends like those discussed for all the previous cases.

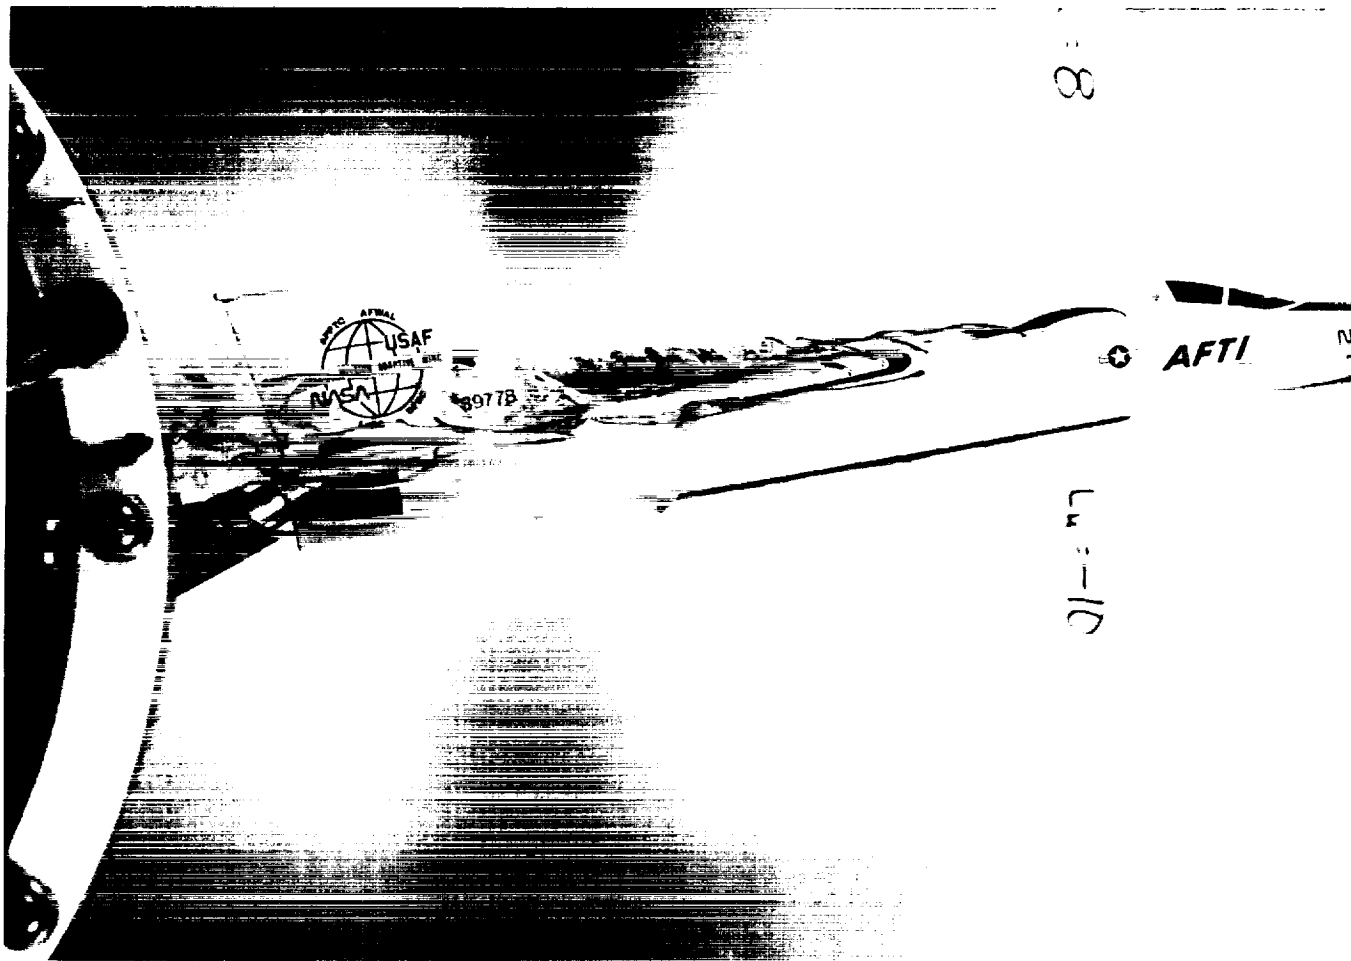
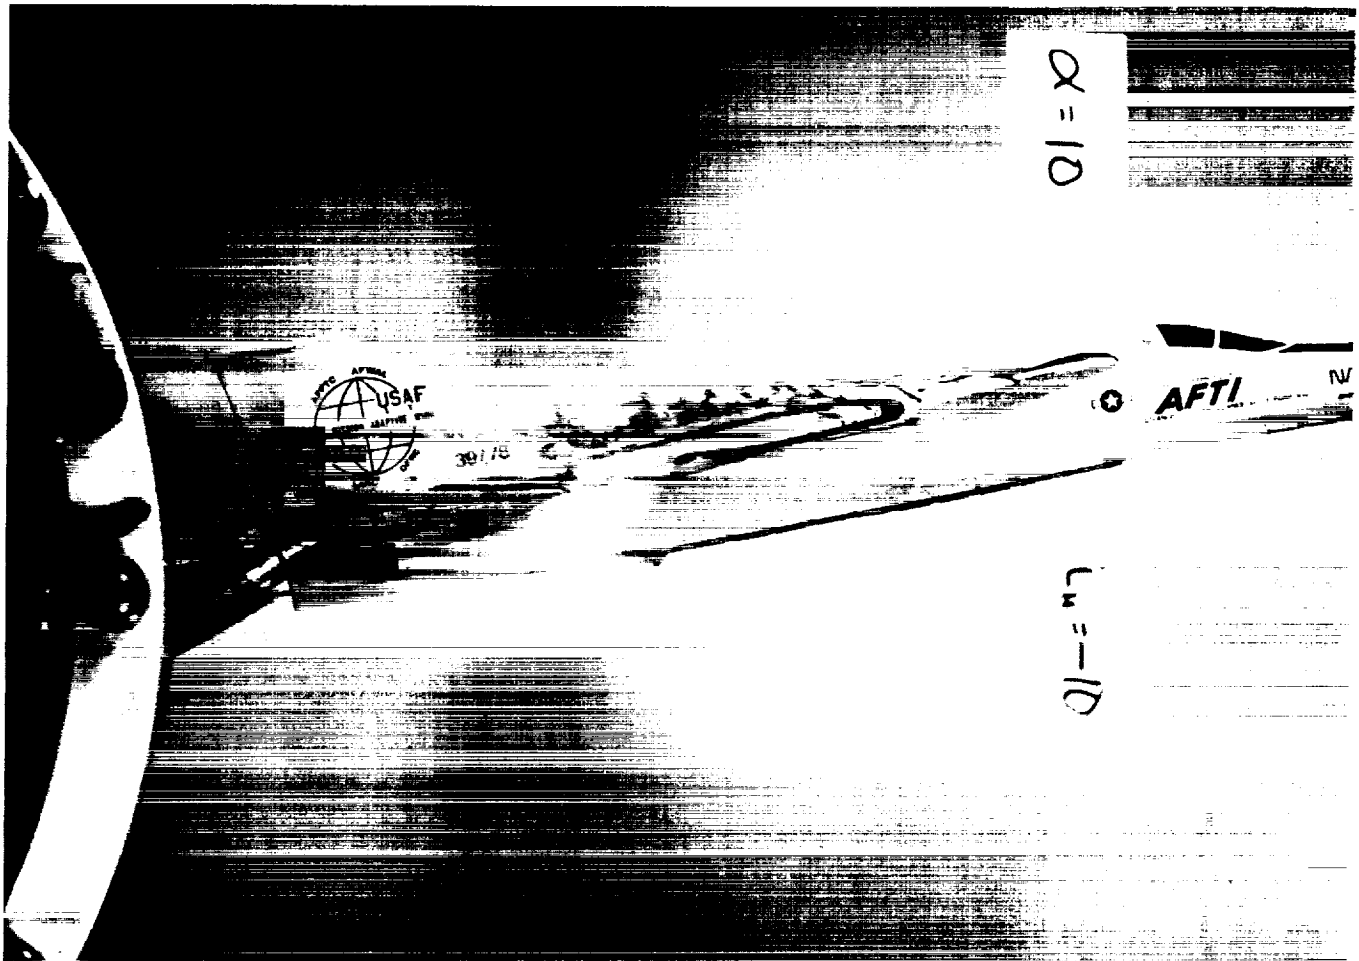
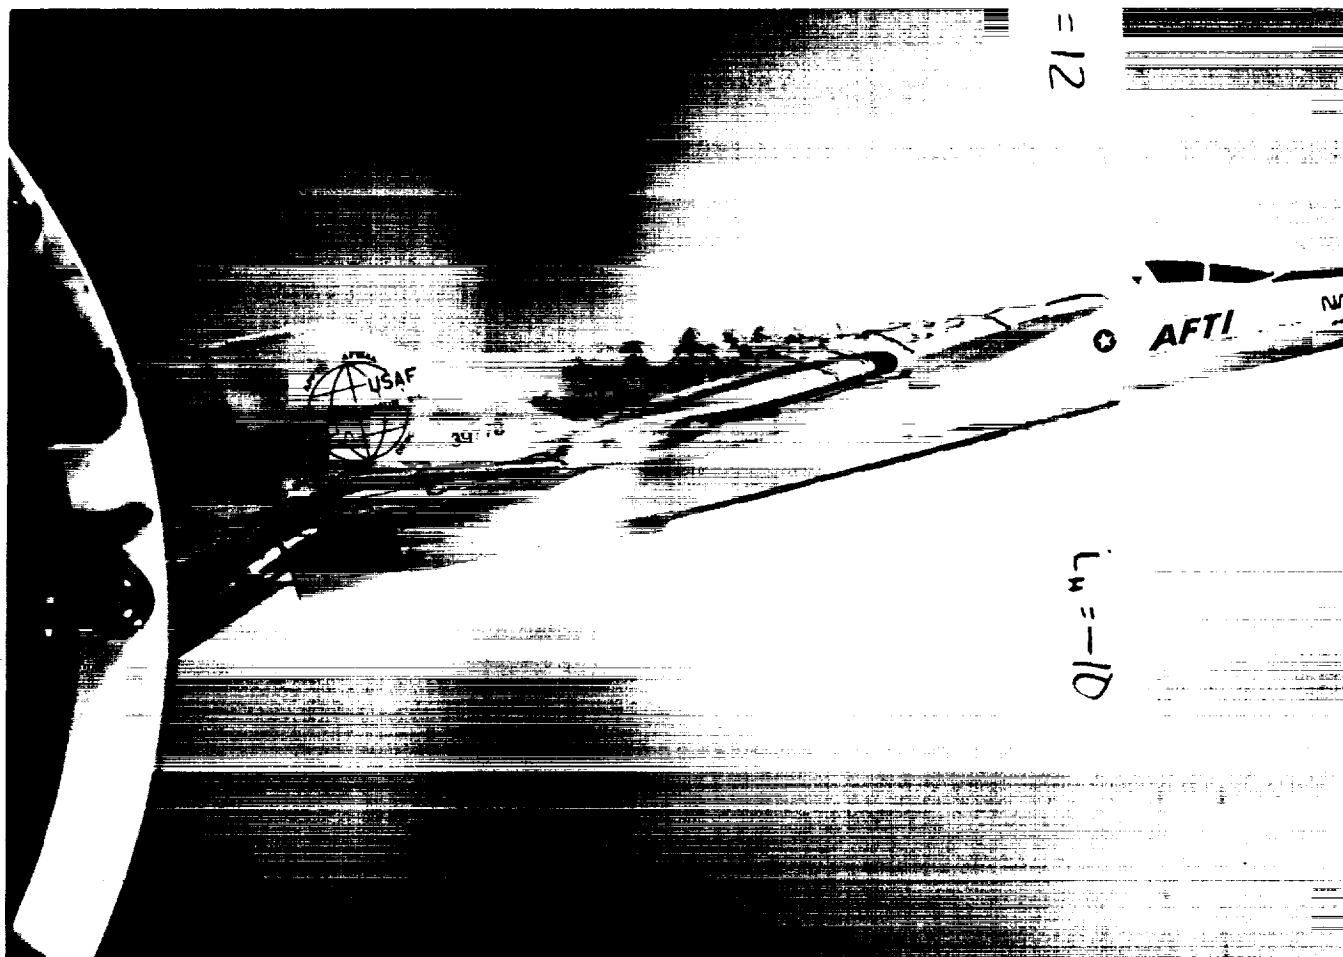
By looking at the side views for this configuration (figs. 13(b), 14(b), and 15(b)), it is noted that the path that the separated and glove vortex flow takes is most similar to that of the $\delta_{LE/TE} = 10/10$ camber configuration (figs. 7(b), 8(b), and 9(b)); that is, a downward turn near the trailing edge causing a more direct interaction with the horizontal tail. The inlet lip vortex also has direct interaction with the horizontal tail, especially at $\alpha = 12^\circ$ (fig. 15(b)).
